## Appendix C – Significant Problem Area Modeling and Recommendations

## Butler County Act 167 Plan

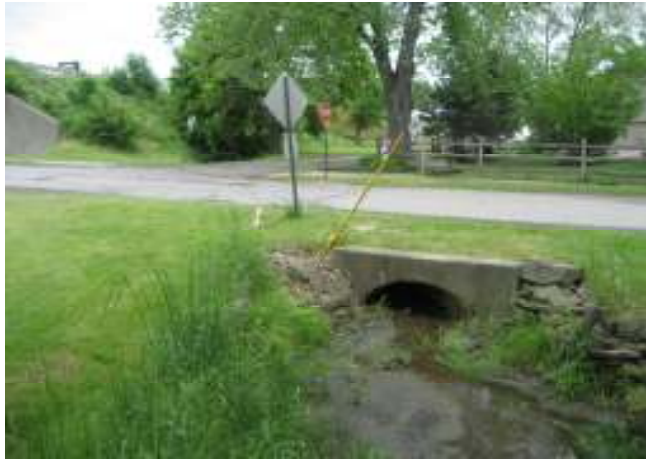
**Problem Description:** The Borough indicates that the problem is Stormwater issues. The elliptical CMP may not have adequate capacity to convey the full stream flow beneath Spring Street.

Upstream end of elliptical CMP crosspipe beneath Spring Street. The small stream may flow over the street during storms.

The capacity of the elliptical CMP should be analyzed to determine if the pipe is large enough. Upstream development may have increased the discharge in the stream. Possibly the farm pond could be modified to store floodwaters during the highest flood peaks to reduce flooding at this location and downstream where the creek flows through the town of Harmony. This solution would require the cooperation of the private landowner, the Borough, and DEP.

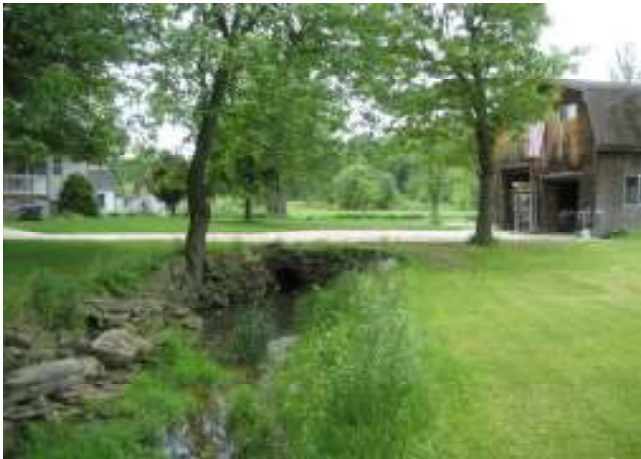
Looking upstream from the elliptical CMP. The stream is the outflow from a farm pond.

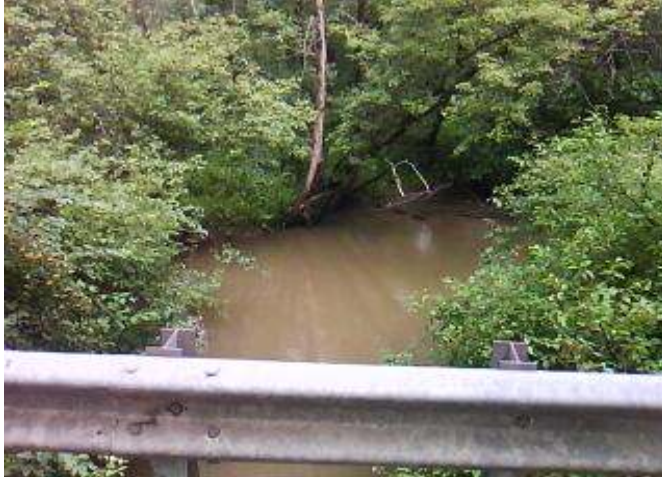
**Problem Description:** There are two sites along Boyers Road and DeMatteis Road that have always flooded frequently. Homes were possibly built in the floodplain.

Looking upstream from  
Dematteis Road bridge.

The bridges may be undersized and act as obstructions during storms, but no debris or sedimentation was reported at either bridge. The problem may be that buildings were constructed in the streams' floodplains. One solution to the problem is for the Township or the County to purchase the properties for public use. A regional flood control facility may not be justified to protect a small number of residents, and it may not be effective since the streams are small and are near the top of the watershed.

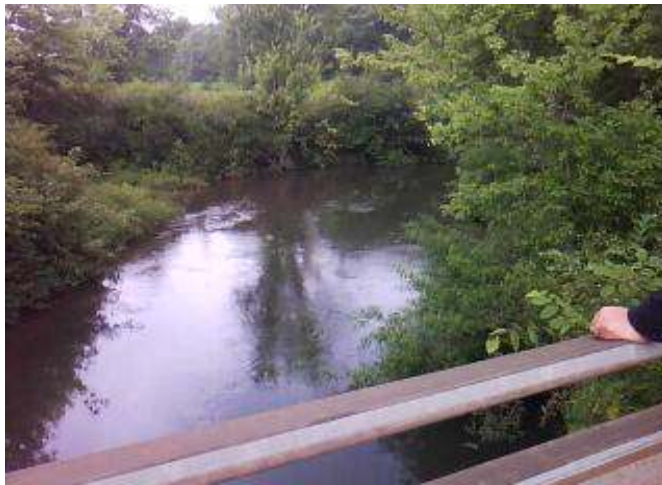
Looking downstream from  
Boyers Road bridge.

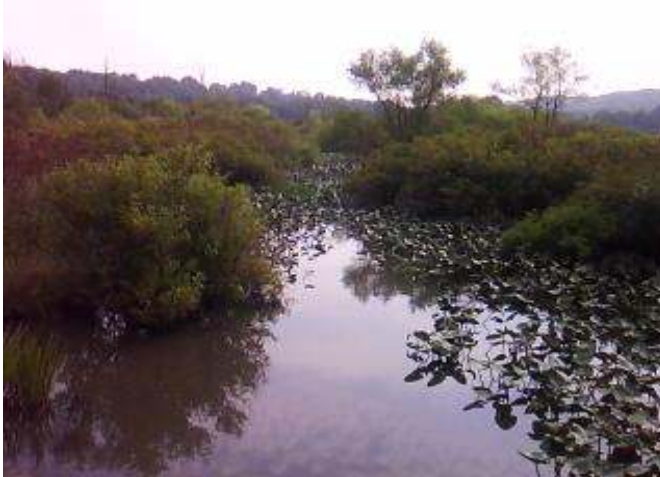
**Problem Description:** Beaver Dam Road - Dams are causing the roadway to flood, and even at dry time, water is almost to roadway level.

Ponded water caused by a beaver dam. The adjacent road floods during storms.

Contact the Pennsylvania Game Commission to determine the best way to relocate the beaver population. For public safety, the roadway may need to be raised above flood stage.

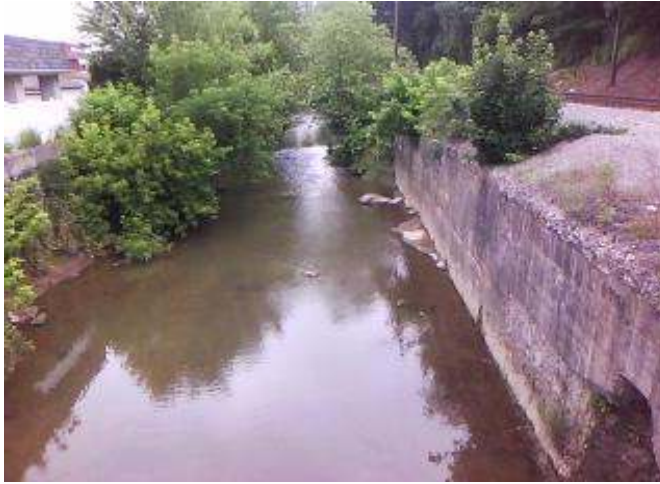
Looking upstream at Breakneck Creek. Note the railroad on the right and the buildings along the stream on the left.

Breakneck Creek is highly channelized through the borough. A rail line runs along one bank. The railbed is supported by a concrete and cut stone retaining wall along the stream channel. The wall appears to be failing in places and causing obstructions. The opposite bank is an eroded slope, with structures constructed in the floodplain.

Sediment and debris have built up in the stream channel. The historic solution to flooding problems was likely to dredge the creek, but dredging causes channelization, increased flow velocities, erosion, and debris issues. Certainly, any obstructions should be removed from the channel, but a regional flood control facility may be warranted upstream to reduce the flood peak in the borough.

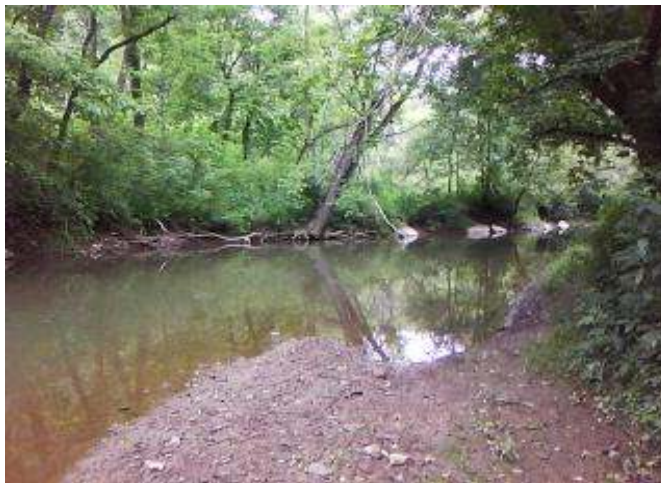
**Problem Description:** Flooding and Obstructions along stream through the town. Siltation, bank erosion, bridge scour.

The far bank of Breakneck Creek shows signs of streambank erosion.

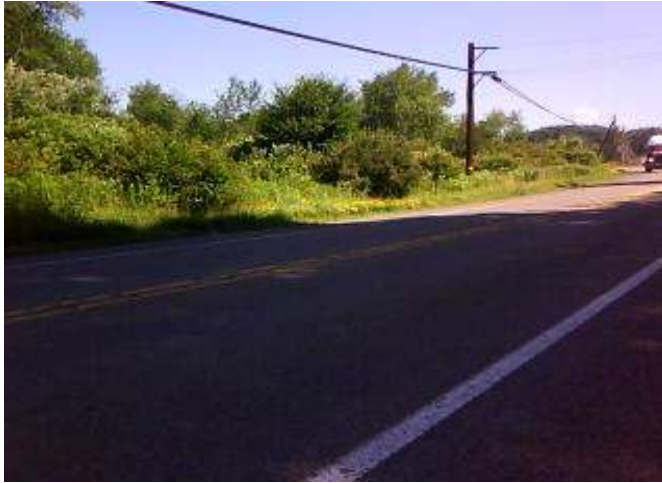
**Problem Description:** Frequent flooding of roadway - Connoquenessing Creek is close to SR 38.

The creek floods this low portion of Route 38.

There is heavy vegetation in the Connoquenessing Creek floodplain. Typically, this is a desirable situation, because healthy riparian foliage increases water quality and decreases overall flooding by slowing flood waters. However, for public safety reasons, the vegetation could be removed at this problem area and downstream to reduce local flooding of the highway. The streambanks and floodplain may need to be armored due to increased flow velocity. Alternatively, the road could be raised, or a regional detention facility could be installed upstream in the creek to store floodwaters.

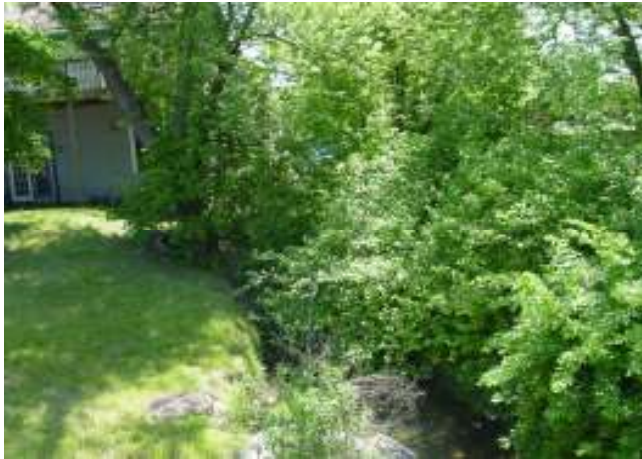
**Problem Description:** The Borough indicates that the problems are increased flow in the creek and flow restriction at the Three Degree Road bridge. The structures upstream of the bridge have been constructed adjacent to the stream channel, and they occasionally get flooded.

Looking upstream from the Three Degree Road bridge. Note the house built along the streambank on the left. There is also a concrete block commercial building located across the stream from the house.

Development in the upstream watershed may cause increased flow in the creek. An upstream regional flood control facility may reduce the highest flood peaks. Alternatively, the Borough may choose to acquire any properties in the stream's floodplain as part of a comprehensive floodplain management project. That way, the Borough could protect and restore the stream's riparian zone while providing a natural public area for its residents to enjoy.

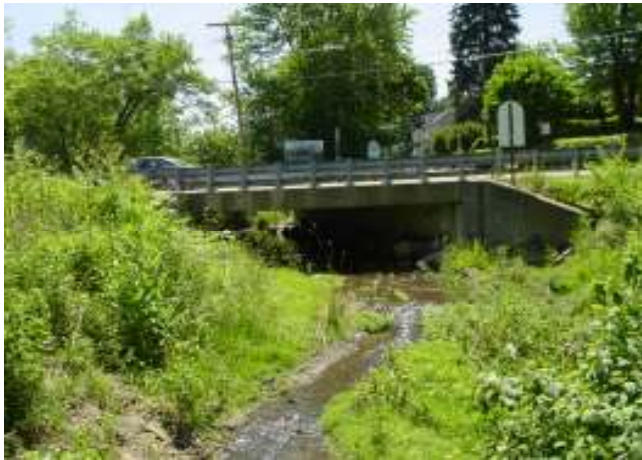
Looking upstream at the Three Degree Road Bridge. The bridge appears to be relatively clear of obstructions.

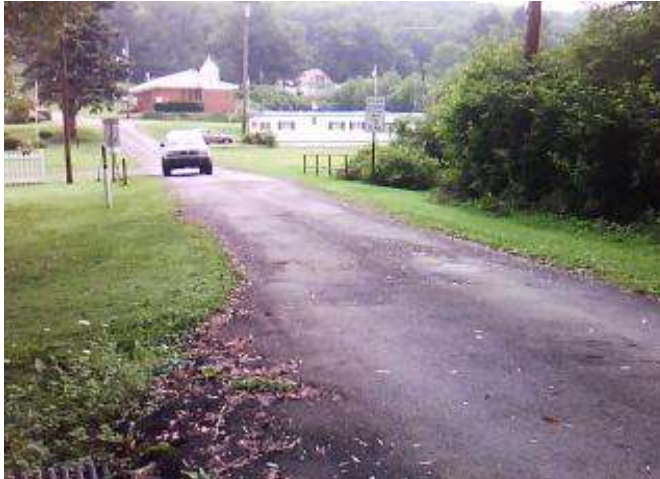
**Problem Description:** Hilliards - The Township re-routed the stream to a new location with a culvert in the roadway. The stream now forms two "L's" and will soon undercut the road. The old County bridge is now underlain with dirt.

View toward the low area of the roadway.

The stream's historic route should be restored. The county's bridge may need to be replaced if it is deficient or undersized. Alternatively, the culvert could be analyzed to determine if it is adequately sized, and the stream's new route could be stabilized with riprap and a healthy riparian zone to prevent erosion and downstream sedimentation .

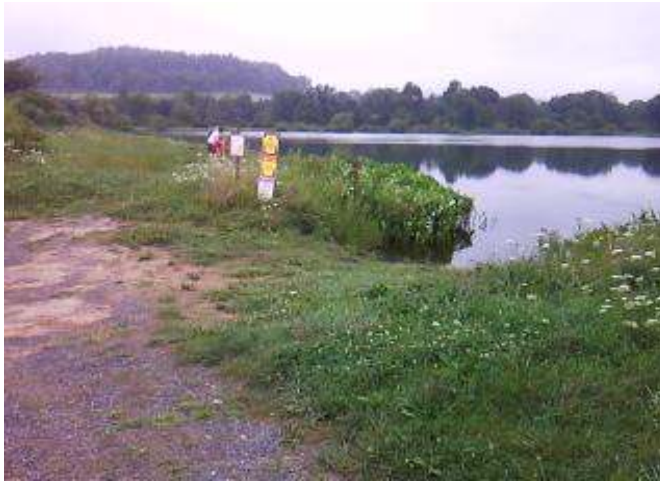
**Problem Description:** Calico Road - Beaver dams have water at road level, and the roadway is being washed out.

Manmade pond adjacent to Calico Road

Contact the Pennsylvania Game Commission to determine the best way to relocate the beaver population. For public safety, the roadway may need to be raised above flood stage.

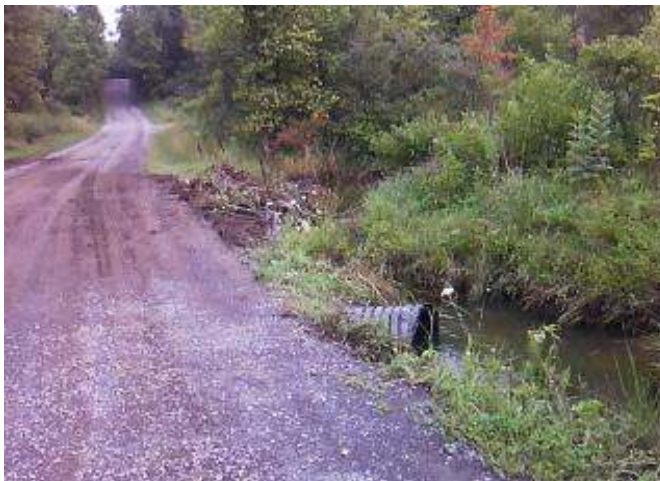
Outfall from the manmade pond has been dammed by beavers. Overflow is causing erosion of the unimproved roadway.

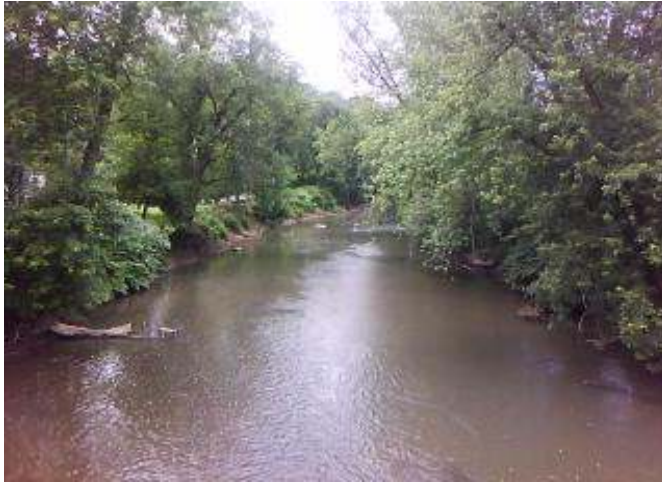
Village of Renfrew and Renfrew Road. Low area next to Thorn Creek.

Looking downstream at Thorn Creek.

Structures and properties along Thorn Creek flood during storm events. If possible, the Township could consider acquiring flood-prone properties and designating them for public use. Alternately, constructing a regional flood control facility upstream would mitigate some of the frequent flooding.

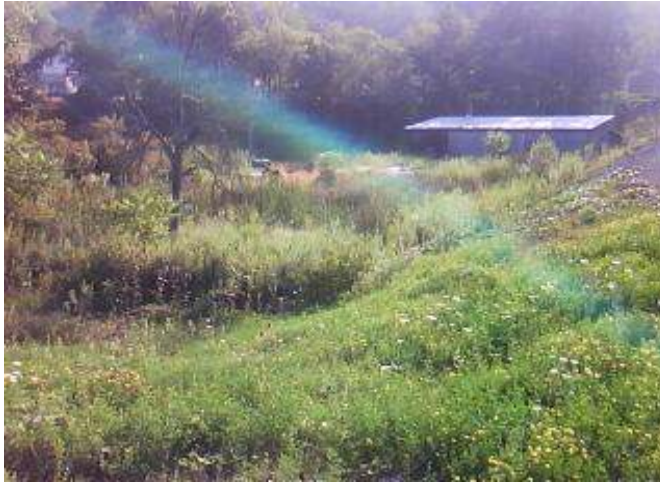
**Problem Description:** Flooding of Connoquenessing Creek at various locations along State Route 38.

A portion of the Connoquenessing Creek floodplain.

For public safety reasons, SR 38 may need to be raised at various locations to prevent dangerous flooding. Or a regional detention facility could be constructed upstream in the creek to store floodwaters.
